Case Study:

Boca Raton Regional Hospital

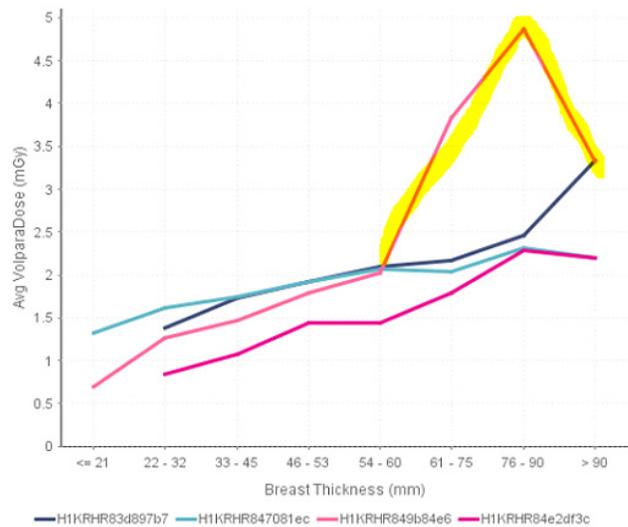
VolparaDose vs. Breast Thickness

Nicole: VolparaEnterprise revealed that the machine in question was reporting those dose alerts only within a certain range of thicker breasts.

Nicole: We then used VolparaEnterprise to investigate the root cause of the dose alerts. We compared the performance of the x-ray machines in the department and found that the dose distribution was much worse on the one machine; however, it was an issue with calibration, not actual dose deliverance. Once the physicist recalibrated the system, the alerts were minimal.

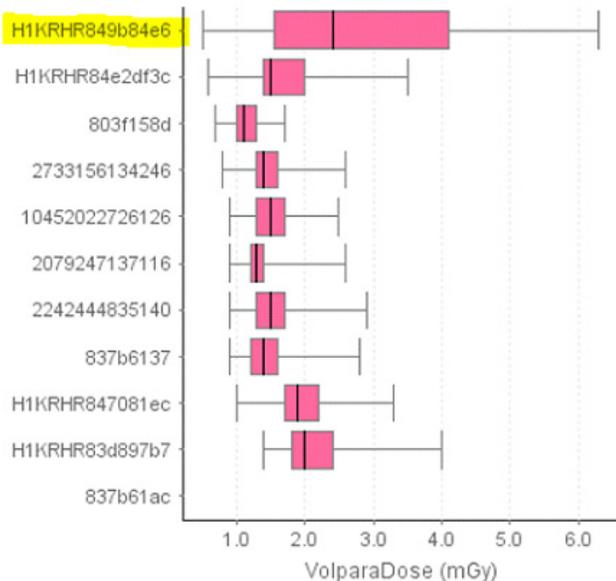
VolparaDose by Mammography:

Shakira: It was pretty obvious from VolparaEnterprise that the problem was isolated to a single machine.

Nicole (cont'd): Also, we were able to see that fall-outs were occurring when imaging women with thicker breasts.

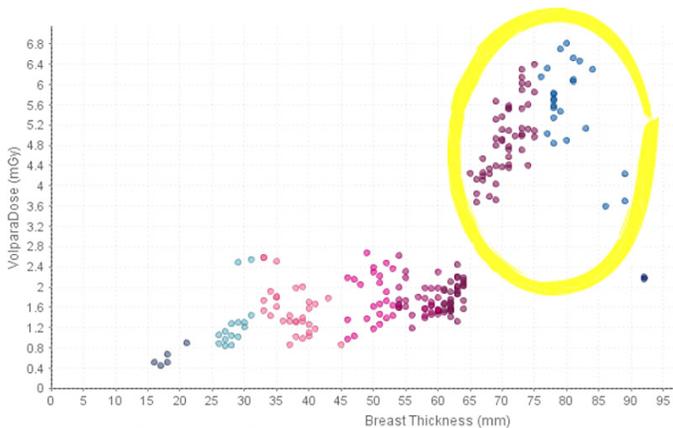
Lisa: By looking at the physics parameters in the DICOM headers for two very similar cases imaged on the identified machine and one other, we were able to figure out that one machine had an HVL setting that was very, very different than that of the other machine.

Normal	Problem
Entrance Dose mGy	11.5	9.5
HVL	0.493	68.9
Glandularity %	11.48	16.52
Target	Mo	Mo
Filter	Rh	Rh
Filter Thickness mm	0.03	0.03
Breast Thickness mm	76	71
Volpara Dose mGy	2.19	5.88
Manual Volpara Dose mGy	2.3	5.7

Dr Shilling: In the end, it turned out to be a very simple configuration issue during a physicist’s visit. The problem was easily corrected, and only affected the reported dose—the actual doses were all within the normal ranges.
